Manhole Inspection Summary

Manhole # S45EE_001MH

Insp Date: **9/2/09 1:19 PM**

Location Address: **1826 CHASE ST**

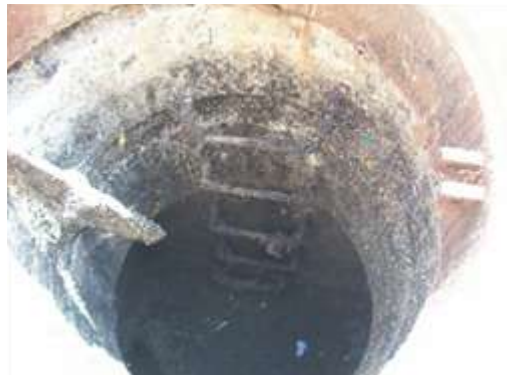
Defect 2

Comments **A lot of debris in the manhole**

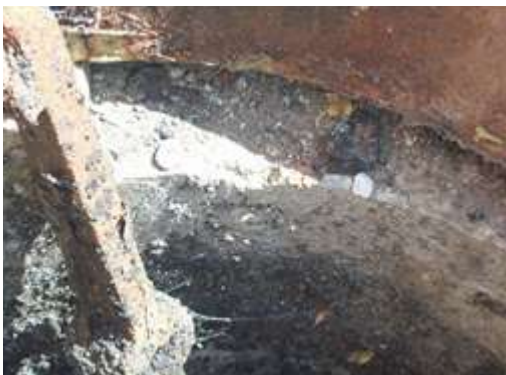
Defect 1

Offset: **2.5** (in.)

FRAME OFFSET

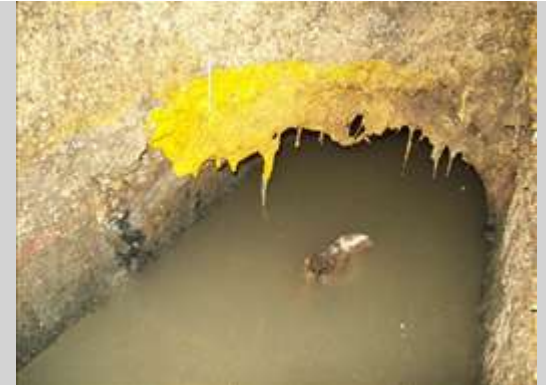
12 O'Clock Outflow

36 in. Circular Gravity Sewer
Pipe Out @ 12 O'Clock

Invert Depth: **10.20** (ft.) Flow Characteristics: **Slow**

Deposits: ☒ None ☐ Mud ☐ Sludge ☐ Debris ☐ Grease

Infiltration: **None**

Pipe Seal Cond: **Sound**

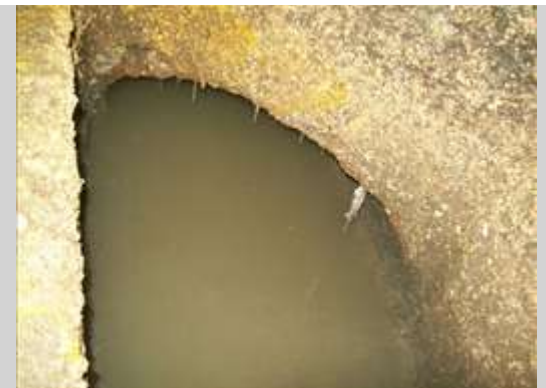
3 O'Clock Inflow

36 in. Circular Gravity Sewer
Pipe In @ 3 O'Clock

Invert Depth: **10.20** (ft.) Flow Characteristics: **Slow**

Deposits: ☒ None ☐ Mud ☐ Sludge ☐ Debris ☐ Grease

Infiltration: **None**

Pipe Seal Cond: **Sound**

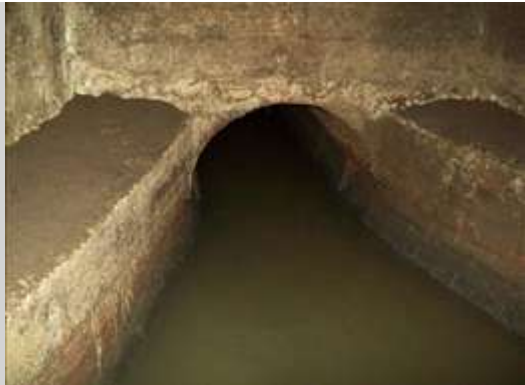
6 O'Clock Inflow

36 in. Circular Gravity Sewer

Pipe In @ 6 O'Clock

Invert Depth: **10.20** (ft.) Flow Characteristics: **Slow**

Infiltration: **None**

Pipe Seal Cond: **Sound**

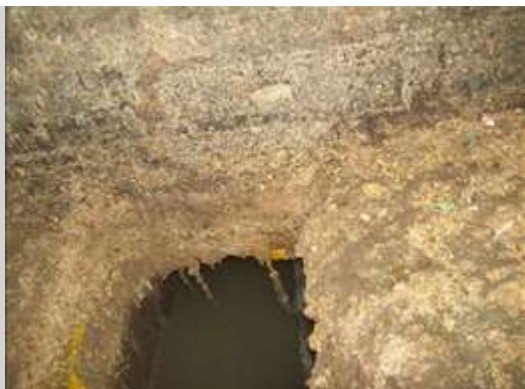
11 O'Clock Inflow

36 in. Circular Gravity Sewer

Pipe In @ 11 O'Clock

Invert Depth: **10.20** (ft.) Flow Characteristics: **Slow**

Infiltration: **None**

Pipe Seal Cond: **Sound**
